Sujet : [INTERNET] Chateauponsac éolien en projet
De : claudia bawden <baud24@hotmail.com>
Date : 25/10/2021 10:51
Pour : "pref-enquete-publique@haute-vienne.gouv.fr" <pref-enquete-publique@haute-vienne.gouv.fr" </pref-enquete-publique@haute-vienne.gouv.fr>

Rain Erosion Maps for Wind Turbines Based on Geographical Locations: A Case Study in Ireland and Britain

K. Pugh¹ · M. M. Stack¹

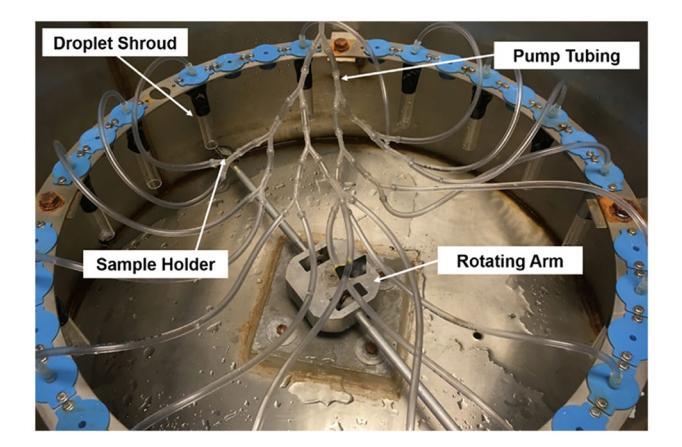
Fig. 1 Whirling arm rain erosion rig

Upon the completion of this map an experimental process in the Tribology laboratory at the University of Strathclyde was carried out to relate rainfall across the country to the degradation of wind turbine blades. There are many different ways to test for rain erosion [8]; however, the test method used for this case study is the whirling arm setup [9]. This consists of a large chamber with induced rainfall from hypodermic needles; in the centre of the chamber is a rotating arm which holds the material sample at the end. Adjusting the rotational speed of the spinning arm will adjust the impact velocity the sample encounters with the water droplet. The experimental setup can be seen in Fig. 1 and a schematic is shown in Fig. 2.

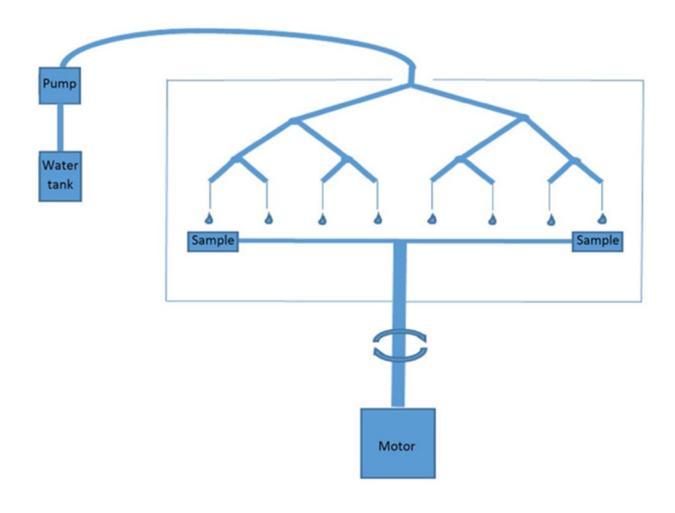
Fig. 2 Whirling arm schematic

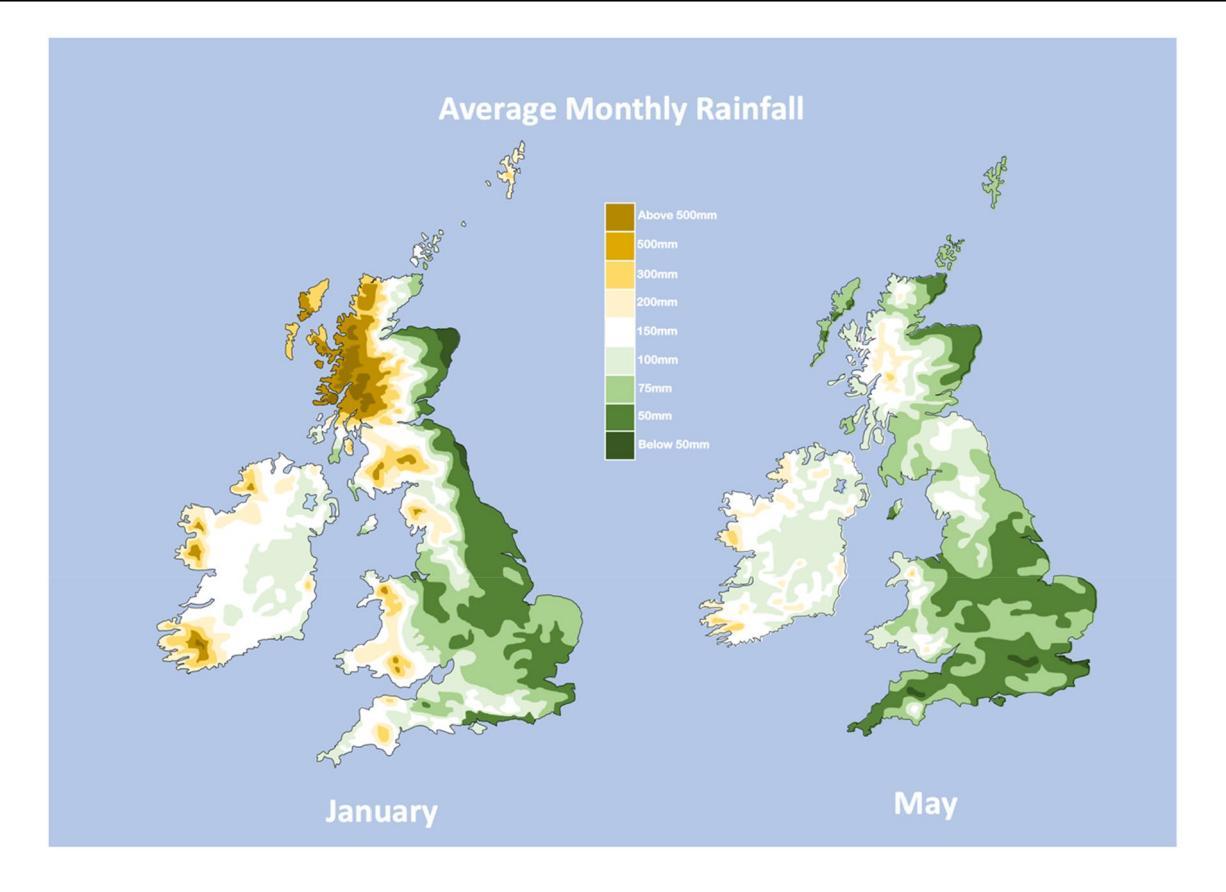
Fig. 3 The average rainfall in the months of January and May

allow for contrast to be observed between the 2 months. The result of this can be seen in Fig. 3.

The construction of the rainfall map (Fig. 3) allows the setup for the experiment to be finalised. The key to the map displays: Below 50 mm, 50 mm, 75 mm, 100 mm, 150 mm, 200 mm, 300 mm, 500 mm and above 500 mm. The rainfall rate of the whirling arm rig is 50 mm/h therefor the time each sample exposed to rain erosion can be determined, this is.

The rainfall mostly averages between 50 and 500 mm of rain with some few areas showing more extreme rain. It is clear that the month of May experiences considerably less rain as it shows highs of 300 mm whereas this rate is fairly common in January. The areas of intensity are very similar in both months with the west coast of Scotland showing a high rainfall and also the west coast of Ireland, predominantly the south west coast of Ireland displaying very heavy rainfall. These are historically harsher climates due to the prominent westerly wind from the Atlantic [12]. This leads to further erosion as the largest windfarms are located in these areas due to the increased power output from the consistent wind [13]. This is a very common trade-off when building a windfarm as the conditions that yield the most power generation are also the conditions which deteriorate the turbine blades most rapidly, therefore the life of the turbine blade will be reduced [14].

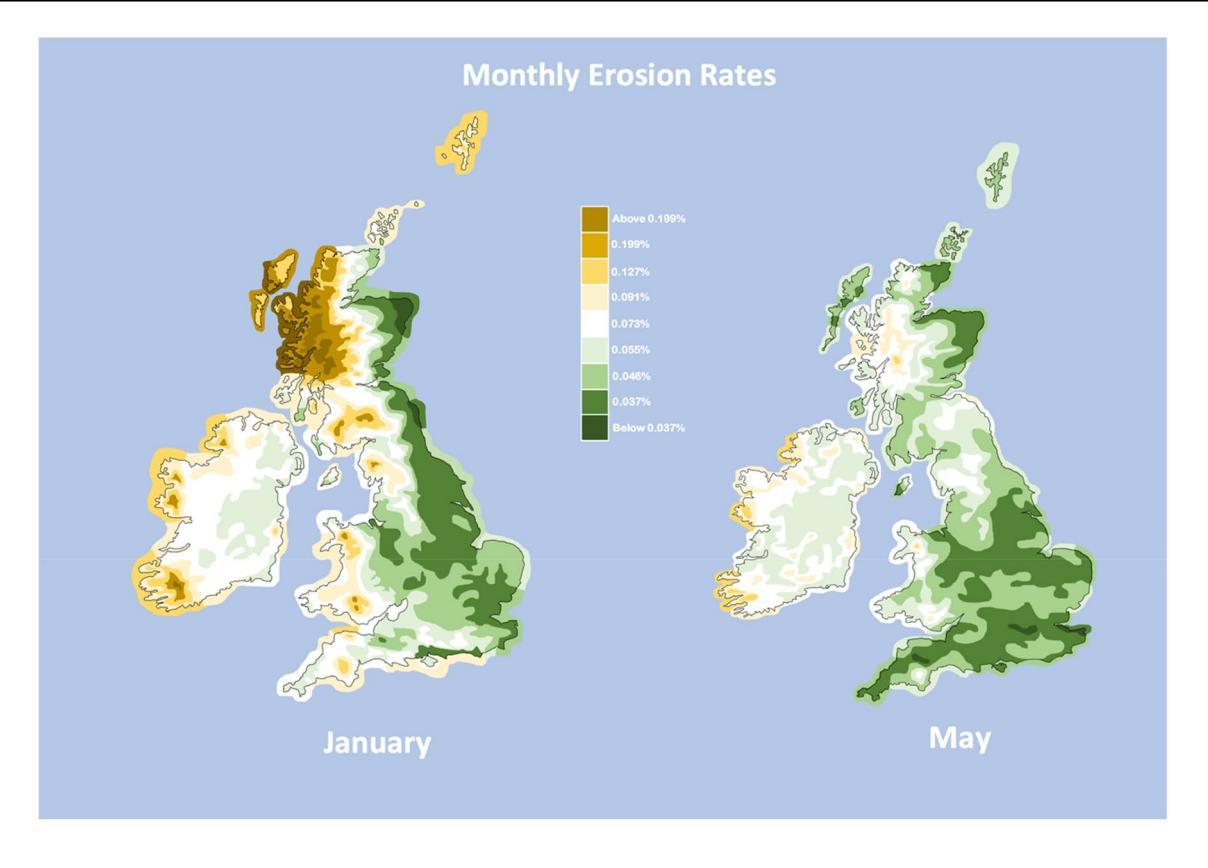
Fig. 4 The monthly erosion rates in January and May

Once the rainfall maps were created the link between rainfall rate and erosion rate could be made as mentioned previously. This allowed the same maps to be created with the key displaying erosion as a percentage mass loss of a theoretical turbine blade.

The rainfall data is only available on land, therefore there was no offshore rain data to compare to the offshore erosion data. From the experiments using saltwater (3.5% saline solution) there was a higher mass loss at the higher exposure times compared to the neutral water tests. To compensate for this a border of approximately 10 miles was created offshore around the islands and assumed to be one grade above the adjacent onshore erosion rate. For example, the mainland of Shetland displayed an erosion of 0.046% mass loss therefor a 10-mile boundary off the coast of Shetland was created displaying the next grade up in the key which is an erosion of 0.055% mass loss. This is displayed in Fig. 4.

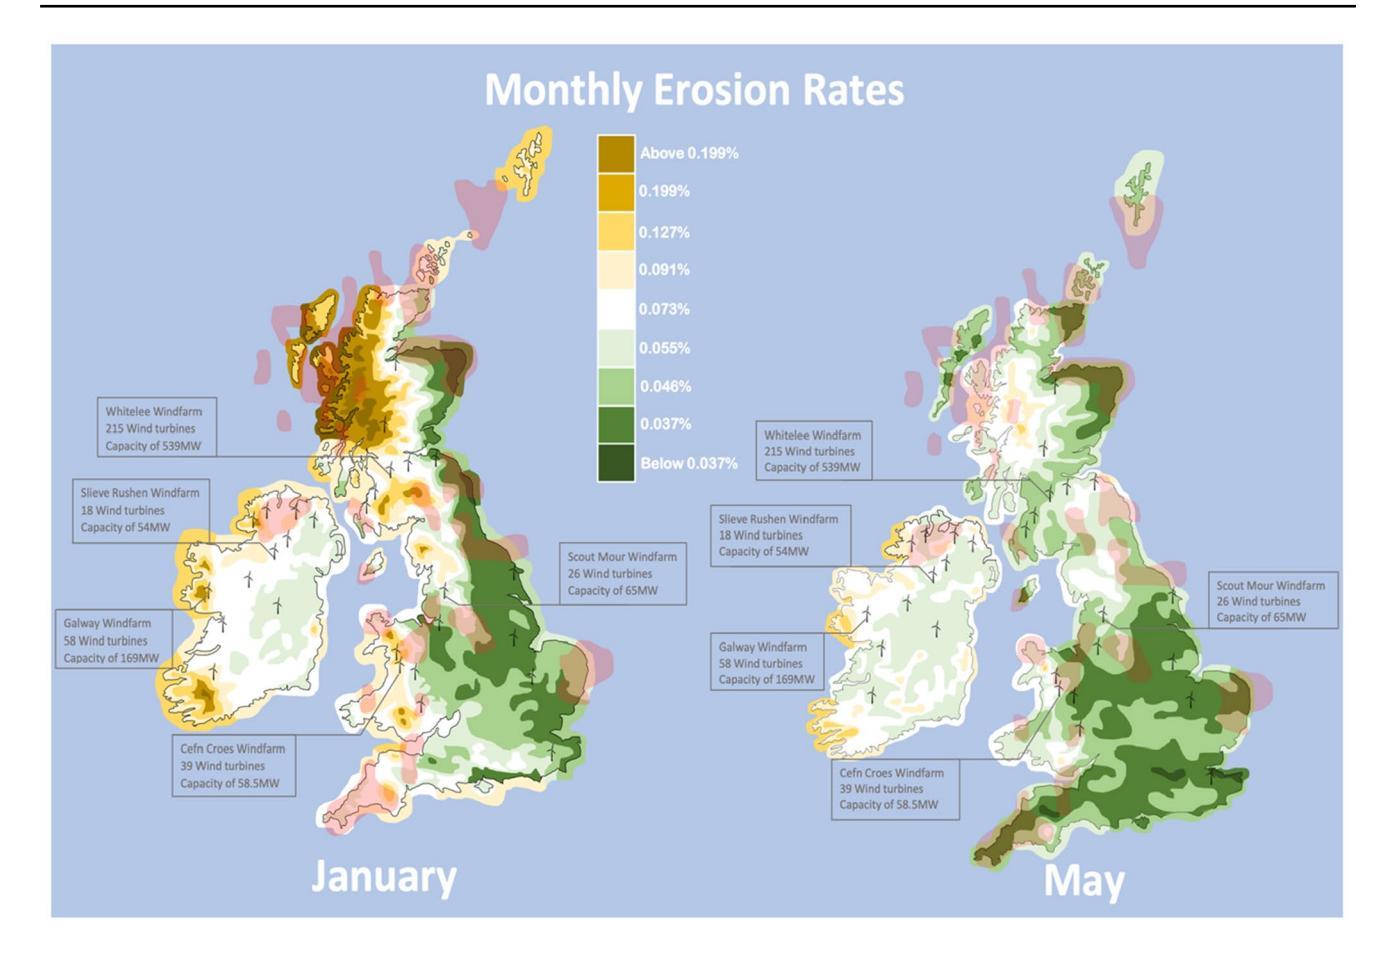
Fig. 5 The monthly erosion rates in January and May with overlays of major wind turbine farms and areas of frequent hail

Construction of these maps now allows for further comparison to be made including locations of major wind farms and also areas of high hail rates which is displayed in Fig. 5. Even though the rainfall rate maps cover all precipitation, it is important to locate areas of high hail impact as these tribological actions can be detrimental to its structural integrity. Although the probability of hail striking wind turbine blades is very low and the damage would be difficult to ascertain, and it could possibly be masked as the outcome of heavy rainfall erosion, the implications of hail impacts have been proven experimentally to cause substantial damage. In a study looking into ballistic ice impacts, it was shown that the impact would delaminate and crack the composite material [24]. This would not only create a weak point in the blade structure itself but also create an initiation site for rain erosion to occur and for crack propagation into the structure of the blade. The areas of frequent hail are shown in Fig. 5 as the red overlay, and from the maps it is clear that the west coast is more adversely affected by hail. Unfortunately, there was limited data on hail in The Republic of Ireland; therefore, assumptions on this issue for this area of the map need to be treated with caution.

Also superimposed onto the map in Fig. 5 is the locations of some large wind farms and the largest in Scotland, England, Ireland, Wales, Northern Ireland and The Republic of Ireland have been labelled [25]. This not only allows for a comparison between the size of the various windfarms in each region but also how adversely affected each one is by the climate and the subsequent erosion. Most of the windfarms are in compromising locations but, as discussed previously, this is a trade-off between greater access to consistent wind to the lifetime of the blades.
